Attachment A

**Example 1: Video Inspection Report Sheet**

<h1>NEBRASKA AVE. PROJECT</h1>		Location Tampa, FL 33604	
		Operator SHAWN/REY	
7/25/2002 1:16:57 PM			
Session Information			
Session Name	NEBRASKA AVE. PROJECT		
Location	Tampa, FL	Run Number	12
Work Order Number		Pipe Name	24 INCH RCP
VCR Tape Number		Flow Direction	Upstream
Truck Number	0	Distance Traveled	5
Comments			
Pipe Information			
Pipe Name	24 INCH RCP		
Type Of Pipe	RCP		
Size Of Pipe	24 INCH		
Manhole Information			
Start Manhole Number	57	End Manhole Number	57 B
Manhole Location	CROSS WALK W. SIDE CASS & NEBRASKA	Manhole Depth	6 FEET
Manhole Notes			
Manhole Condition			
Manhole Condition	GOOD	Coated	No
Inlet Pipe Size		Outlet Pipe Size	
Amount of Flow		Signs Of Surcharge	
Wall Condition	GOOD		
Lid/Ring Condition	GOOD		
Lid Type		Number of Steps	
Steps Condition			
Reports Generated via TwC SubCam 1.5.25 www.TwCSubCam.com info@twodesigns.com

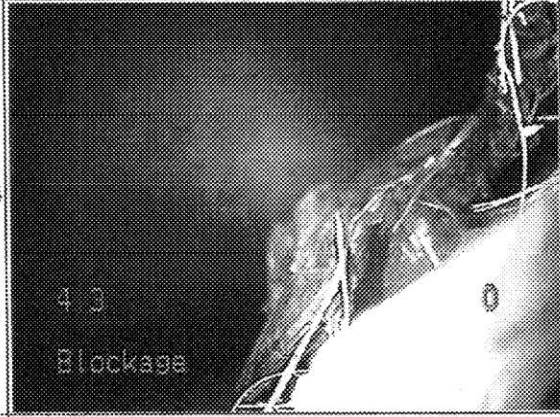
4.3	Blockage Position: None Severity: None	01:22:14 PM

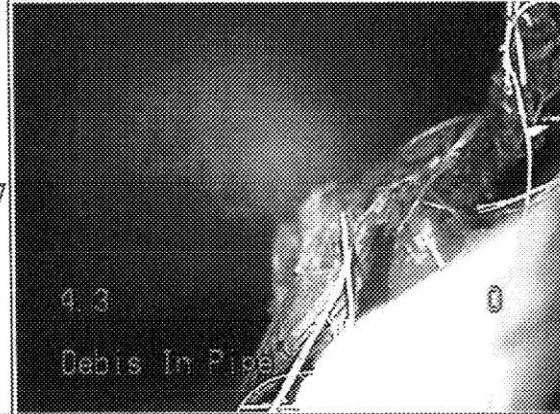
4.3	Debris In Pipe Position: None Severity: None	01:22:37 PM
